# STABILITY OF STRUCTURE FOLLOWING BIRD STRIKE

TECHNICAL REPORT

**TECHNICAL REPORT  
ADS - 60**

**This report was prepared by NAFEC  
under Project 510-004-06X for the  
Aircraft Development Service**

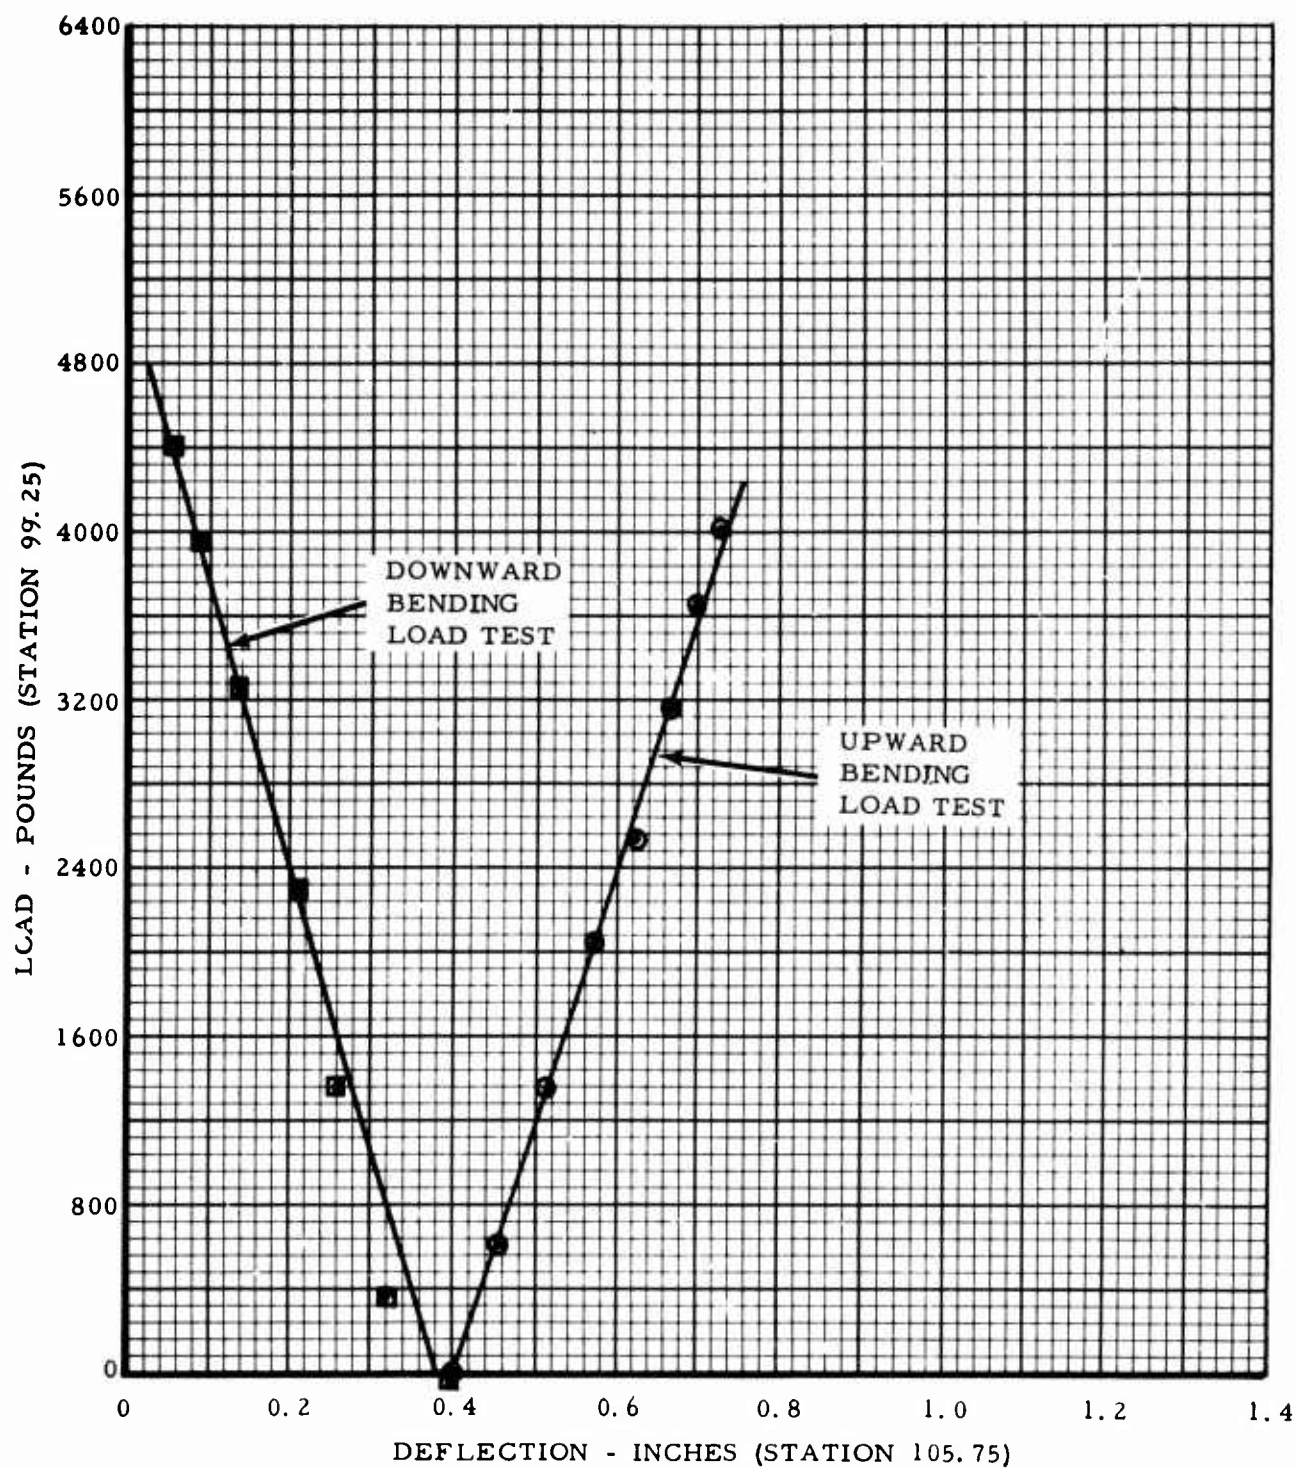
FIG. 1 TYPICAL LOAD-DEFLECTION TEST RESULTS ON A PISTON-ENGINE TRANSPORT AIRPLANE HORIZONTAL STABILIZER

The rigidity of the structure was tested in bending and the structure was vibrated to determine its natural frequency. Figure 1 is typical of the results obtained in the bending load tests made at the various station locations on the tail surface. The load plotted in Figure 1 was applied at Station 99.25 and the deflection was measured at Station 105.75. Since the only bird strike made on the tail surface inboard of Station 99.25, prior to the time this bending test was made, was Test No. 1, Figure 1 is an assessment of the structural damage caused by Test No. 1. The plots of the data result in a straight line, which would tend to indicate that the structure remained within the elastic limit. Also, from the vibration test it was determined that the natural frequency of the structure had not changed sufficiently, after Test No. 1 to indicate that any deterioration of structural strength had occurred.

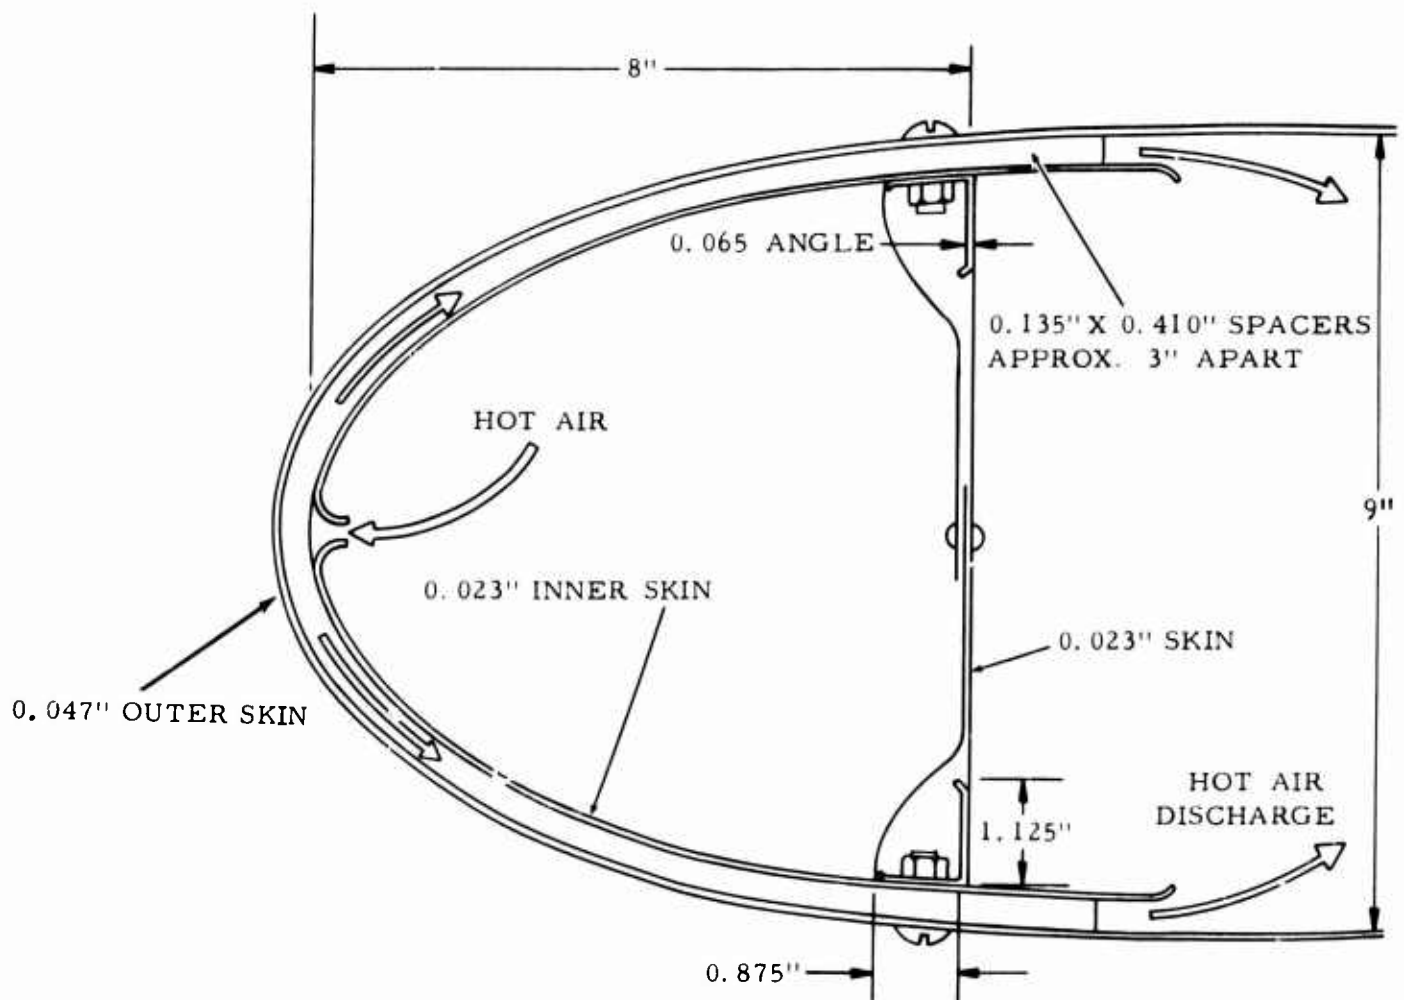
FIG. 8 ORIGINAL LEADING EDGE ON HORIZONTAL STABILIZER OF A  
TURBOPROP TRANSPORT AIRPLANE

Three modifications to the leading edge of the horizontal stabilizer were made to increase its resistance to bird strike damage. The original leading edge is made of two layers of aluminum skin separated by a distance of 0.135-inch by stringers to allow hot air to flow between them for de-icing the leading edge. A typical cross-section of the standard leading edge is shown in Figure 8. The three modifications to the leading edge consisted of a laminated stainless steel splitter plate behind the original leading edge, as shown in Figure 9; a stainless steel leading edge to replace the aluminum, with the addition of two stainless

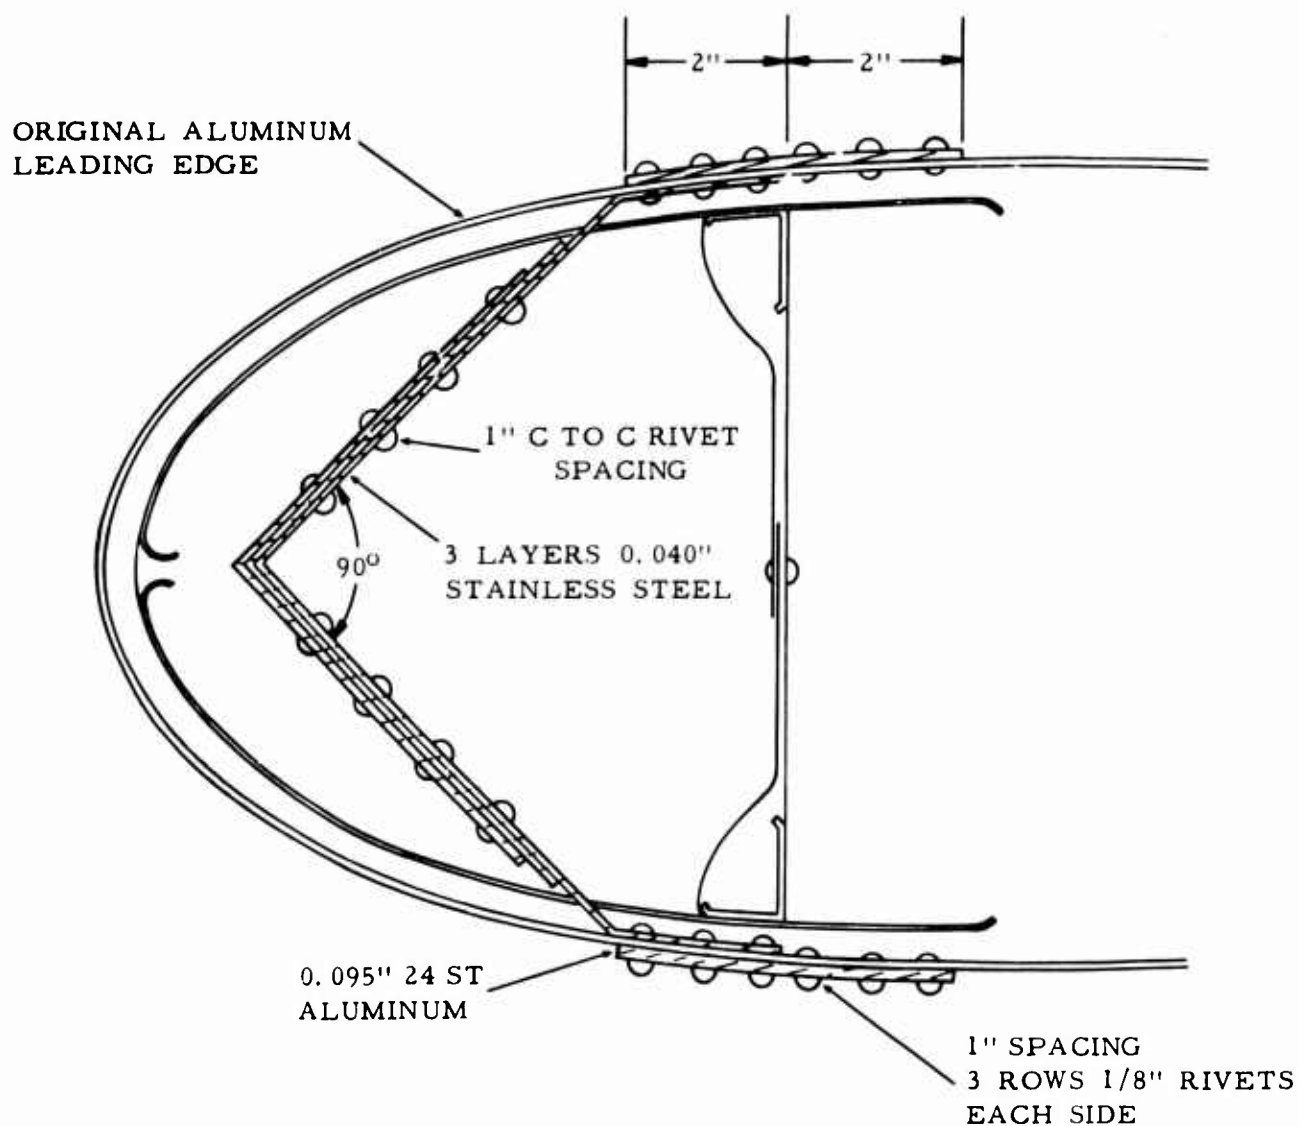
**FIG. 9 LAMINATED STAINLESS STEEL SPLITTER PLATE MODIFICATION  
ON A TURBOPROP TRANSPORT AIRPLANE**

WEIGHT: 5.5 POUNDS PER FOOT

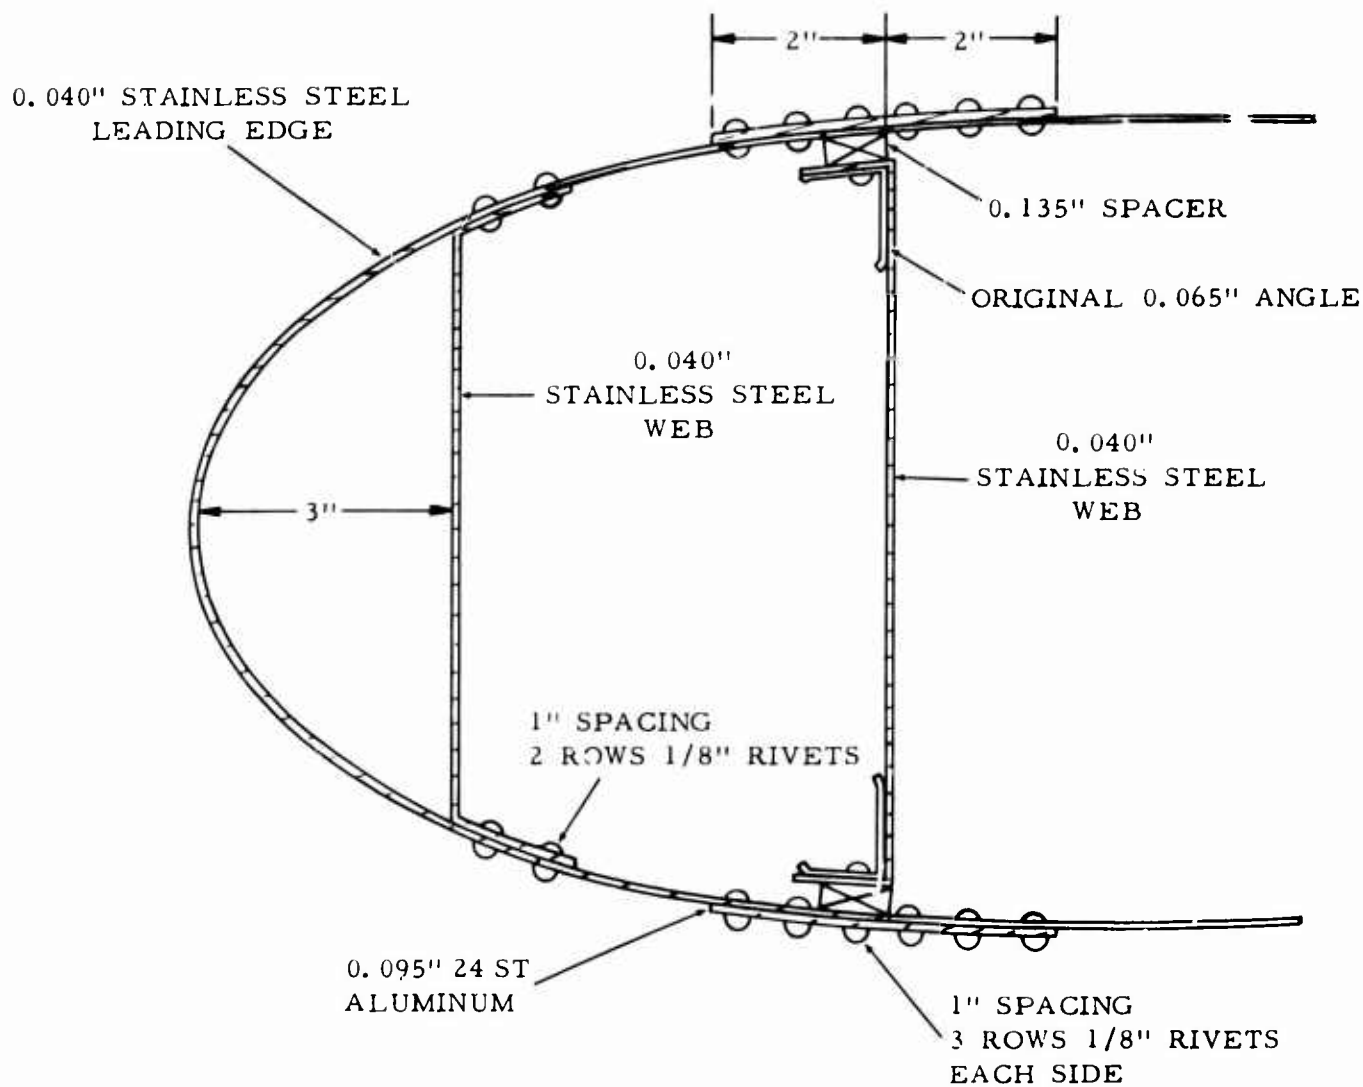
FIG. 10 STAINLESS STEEL LEADING EDGE WITH TWO STAINLESS STEEL WEBS ON A TURBOPROP TRANSPORT AIRPLANE

WEIGHT: 4.5 POUNDS PER FOOT  
 ORIGINAL LEADING EDGE WEIGHED 1.8 POUNDS PER FOOT  
 NET ADDED WEIGHT 2.7 POUNDS PER FOOT

steel webs, as shown in Figure 10; and a stainless steel doubler over the existing leading edge, as shown in Figure 11. Each modification was about four feet long and all were incorporated on one horizontal surface.
